Contractors' All Risks

Site / Development: 4a & 4b, F Lane, City, Postcode

Survey Date: 19 Jul 2022

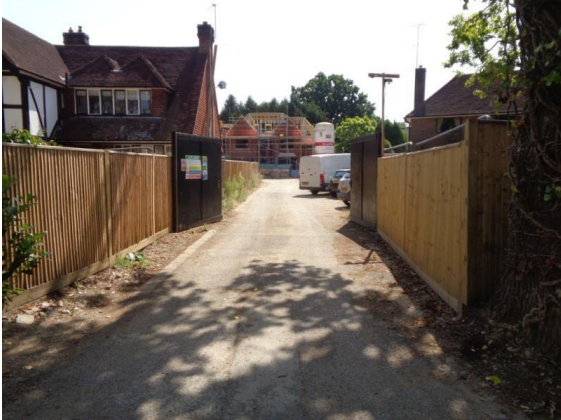
F Lane - access to site

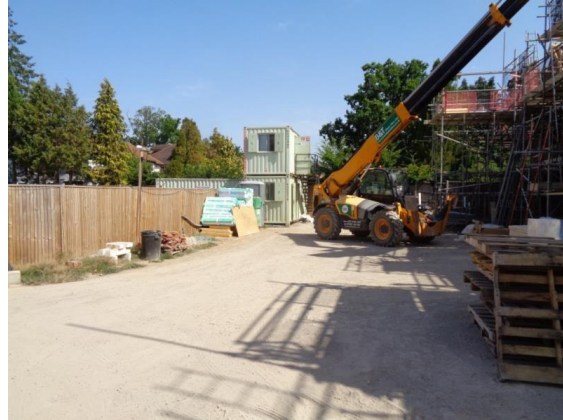
F Lane - working area to front of buildings under construction

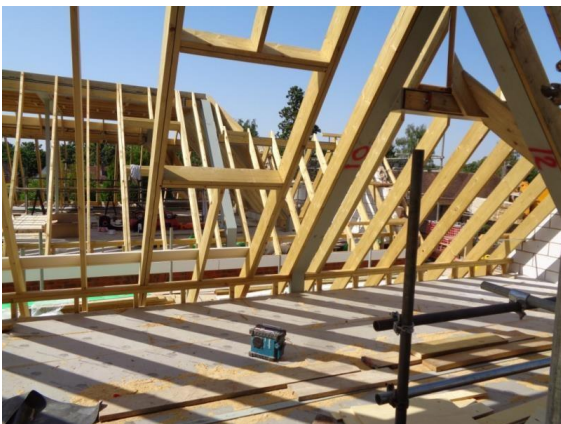
F Lane - typical interior, roof level, at this stage of construction

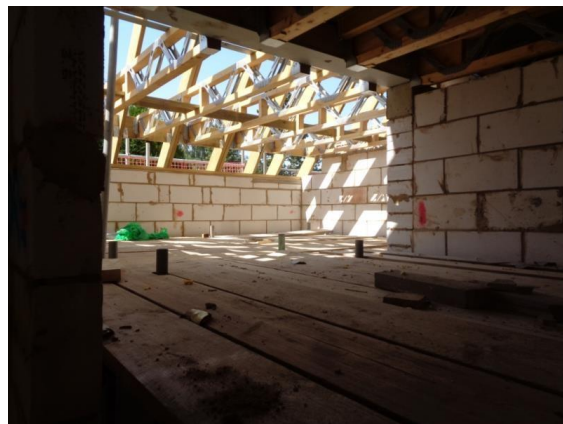
F Lane - typical interior, roof level, at this stage of construction

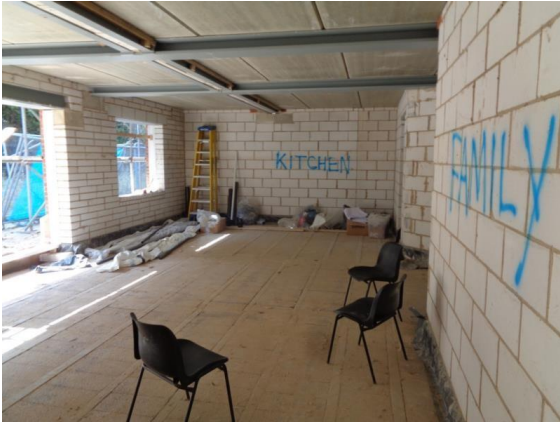
F Lane - typical interior, ground floor, at this stage of construction

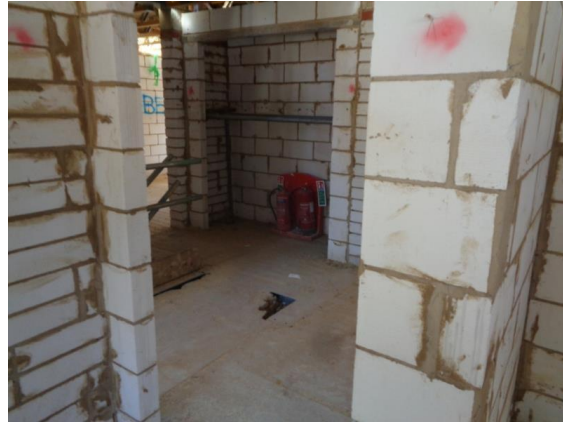
F Lane - typical interior, first floor, at this stage of construction - note fire point deployed

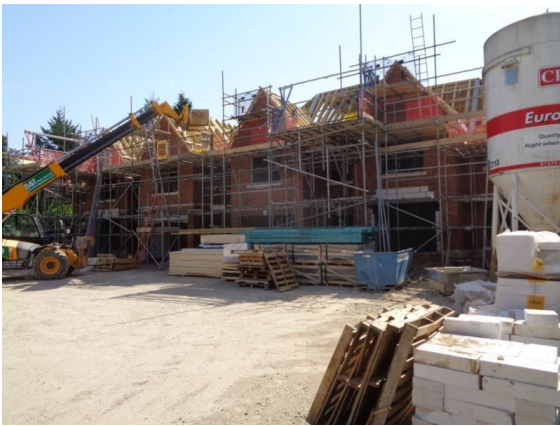
F Lane - front elevation of buildings under construction

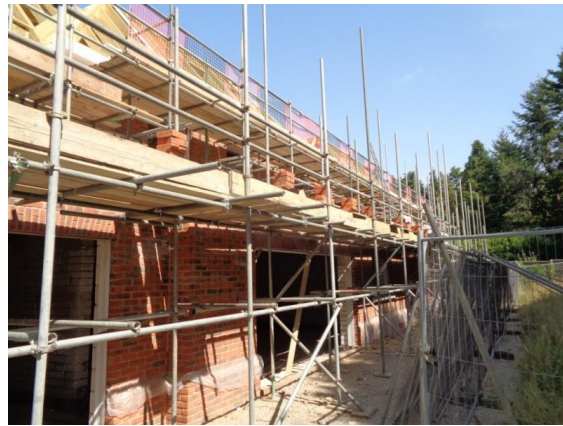
F Lane - rear elevation

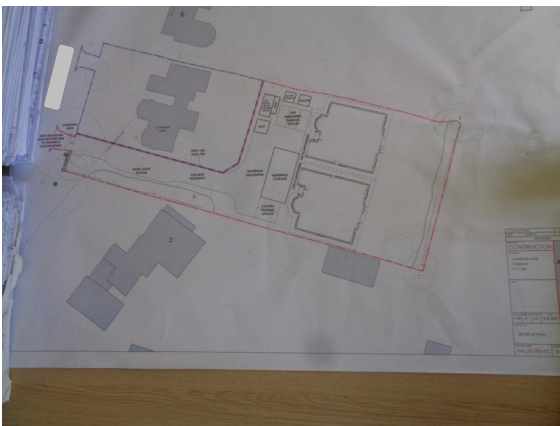
F Lane - site plan showing new houses in relation to boundaries and neighbouring properties (plot 1 (4b) to top, plot 2 (4a) below)
