Property Owners

Site / Development: 1 - 16 Apple Court, Pear Avenue, Blackburn, BB1 2CD

Client Name: Orion 101 Ltd

Survey Date: 1 Nov 2023

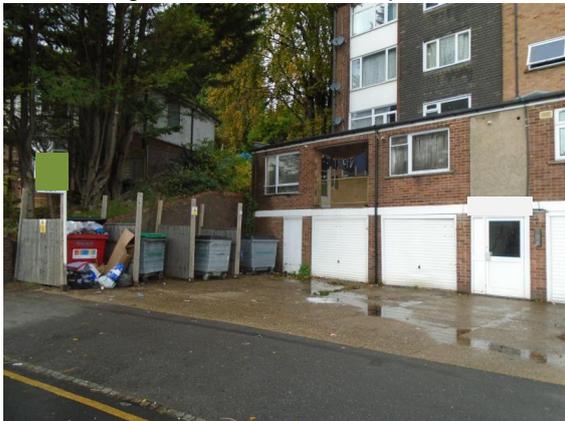
Are all externally stored readily combustible materials clear of the building/boundary?	6	6
Storage is closer than 10m to building but considered adequate for site conditions		
Details: Bags of refuse awaiting collection was noted within 10 metres of the south west corner of the building but considered acceptable.

Refuse collection bays to south west corner of the building.

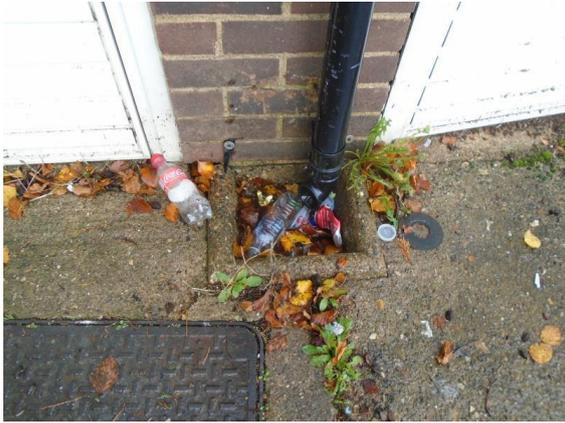
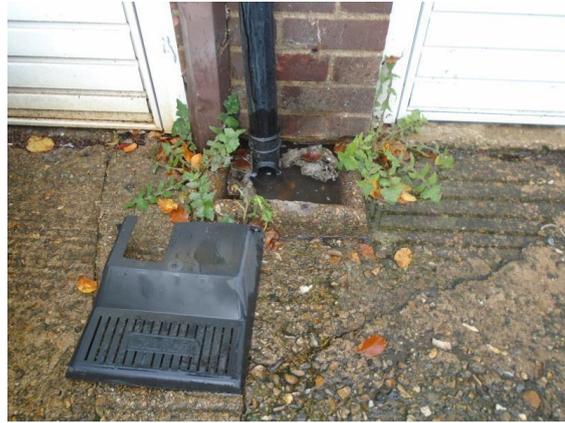
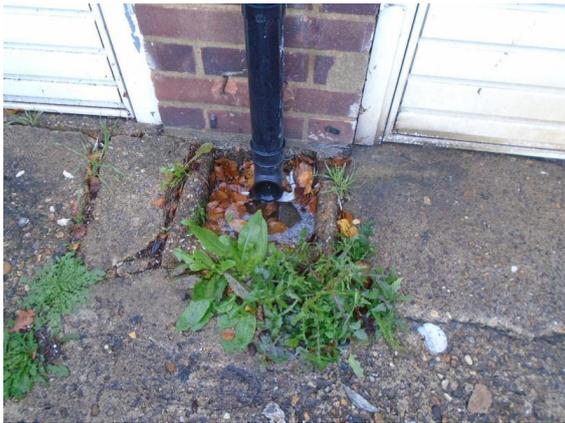
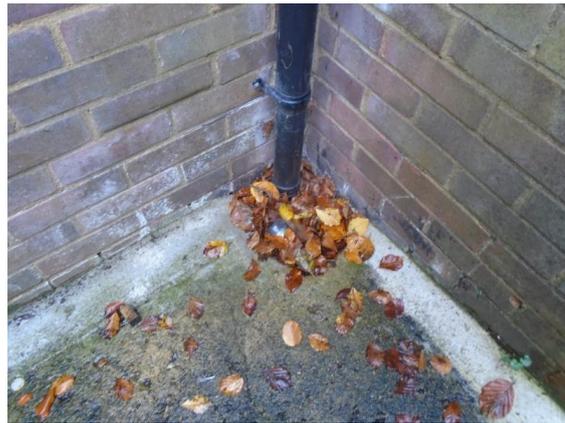
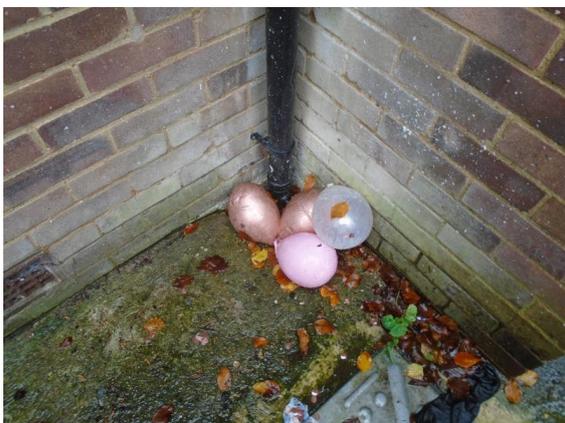
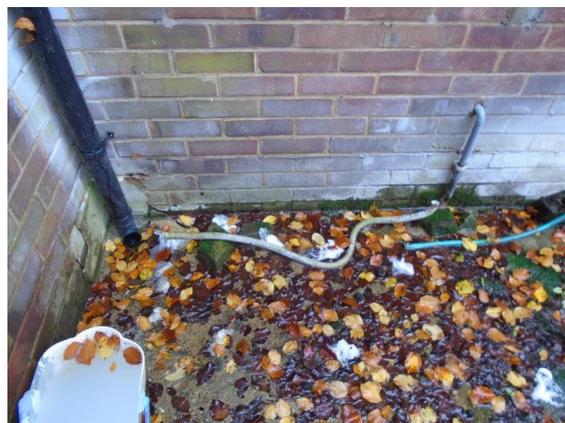
Details: All drains at the front and to the rear of the building were found to be blocked. See photographs and requirement.

Blocked drain to front (1).

Blocked drain to front (2).

Blocked drain to front (3).

Blocked drain to rear (1).

Blocked drain to rear (2).

Blocked drain to rear (3).

All of the blocked drains to the front and rear of the building are to be cleared of vegetation/debris and left in good working order.

Thereafter, the said drains are to be checked/cleared at least annually.

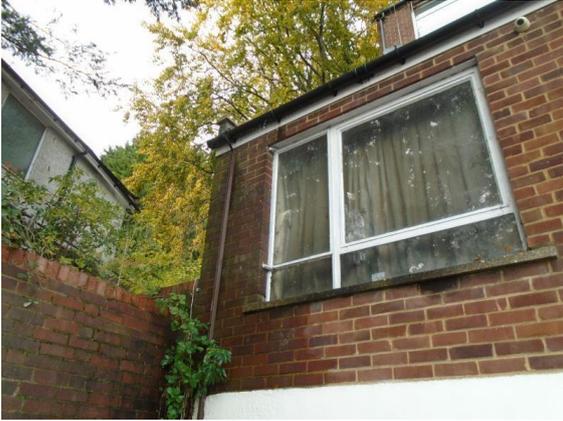
Details: An overflowing gutter above first floor Flat 4 is soaking the wall below. Vegetation was noted to the gutter to the rear three-storey section. See photographs. A requirement is made for all gutters to be checked/overhauled/cleared of vegetation as necessary. A requirement is also made for the seals to baths, showers and sinks within the flats to be checked/re-sealed as necessary.

Overflowing gutter above Flat 4.

All gutters are to be checked/overhauled and cleared of vegetation as necessary. Thereafter, all gutters and downpipes must be inspected at least annually and any blockages cleared.

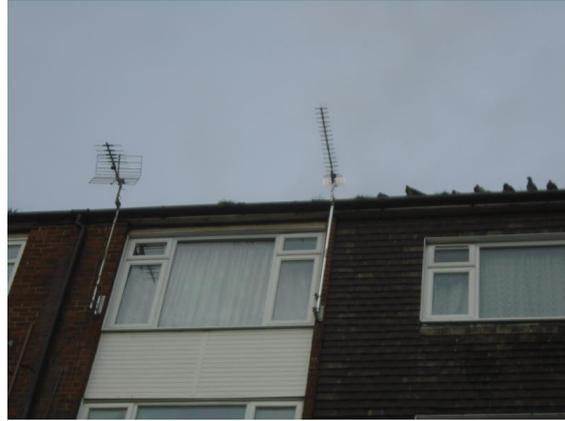
Vegetation in gutter to rear three-storey section.

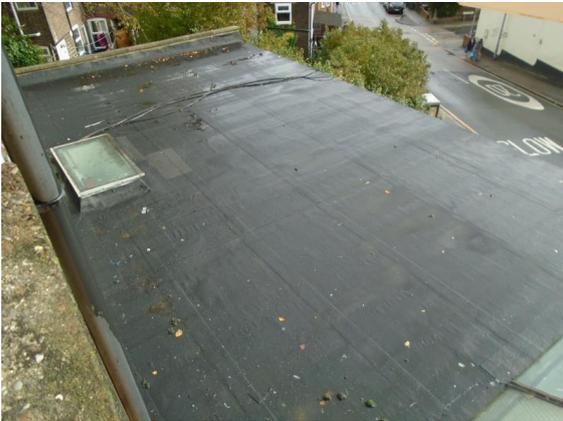
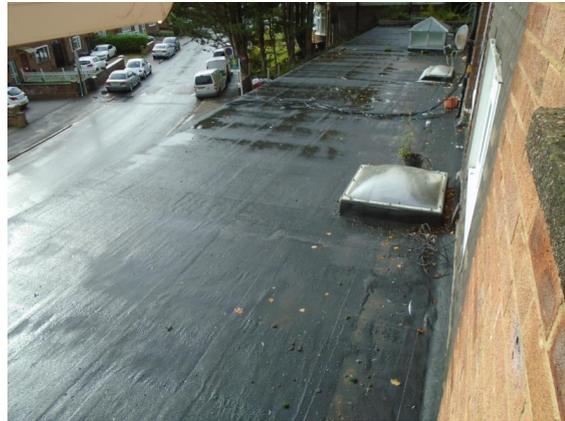
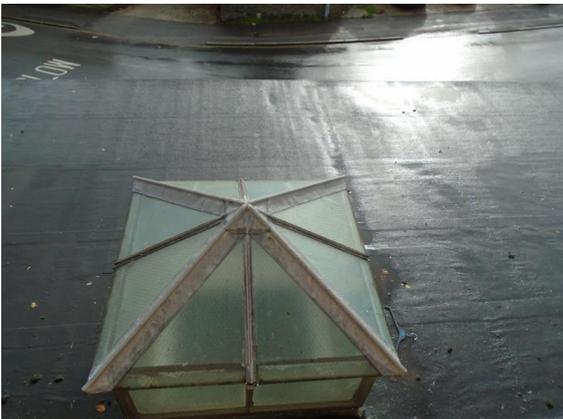
Details: The flat felt roof to the front two-storey section appeared to be in good condition. See photographs.

Flat roof to front two-storey section (1).

Flat roof to front two-storey section (2).

Flat roof to front two-storey section (3).

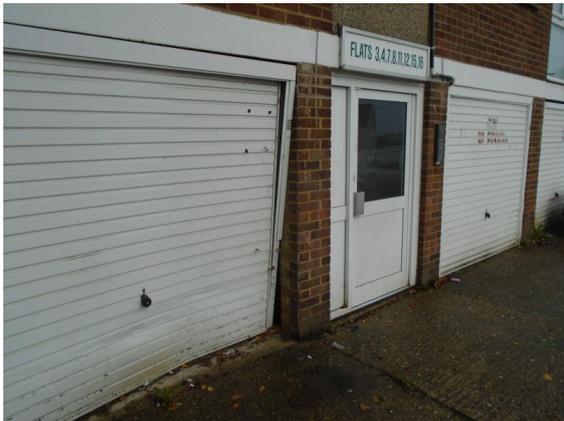
Damaged frame to Garage No. 9.

It is recommended that the damaged door frame to Garage No. 9 is repaired.
